Structural assessment and repair engineering for Alumina furnace, WA

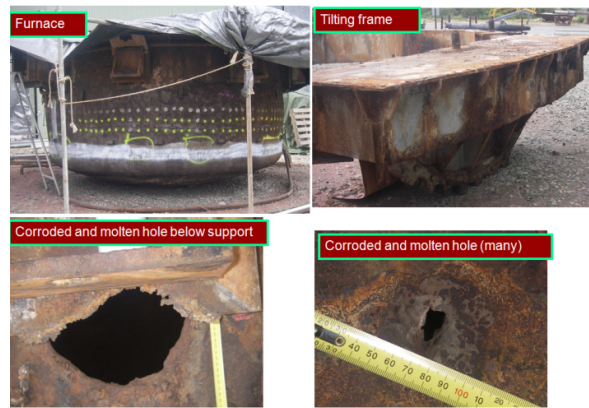
Damaged furnace and tiling frame

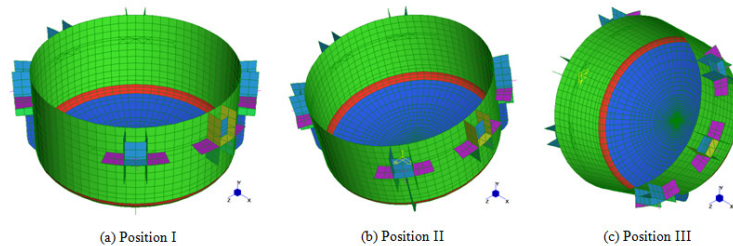
Finite element modelling for the tiling process

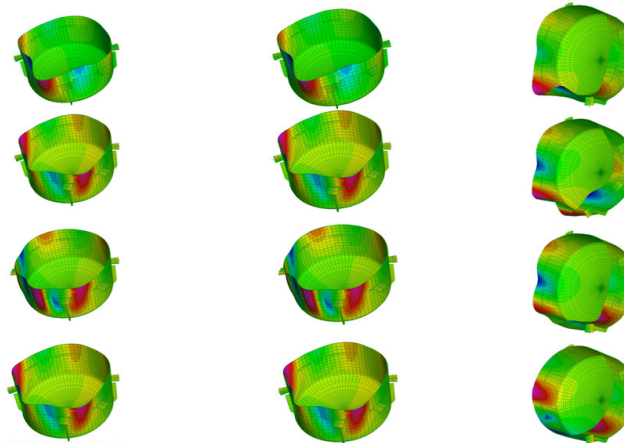
Buckling modes with stiffening at the end of predicted service life
